Manhole Inspection Summary

Manhole # S04YY1003MH

Insp Date: **7/5/06 12:54 PM**

Location Address: **6505 williamson ave**

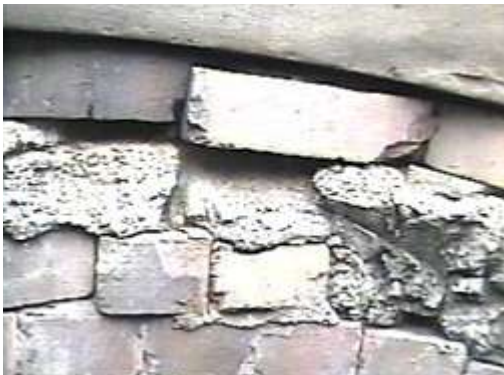
Defect

Condition: ☐ Sound ☐ Cracked ☐ Root Intrusion ☒ **Loose Brick** ☐ Deteriorated

loose brick in frame adjustment

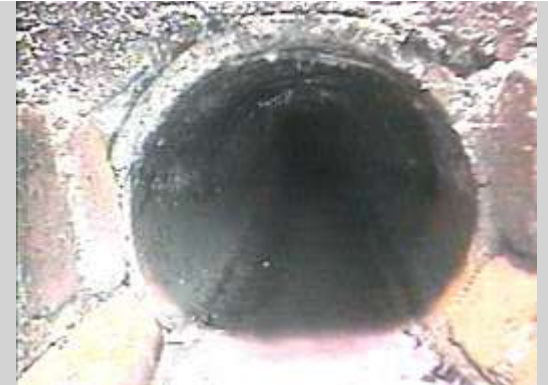
8 in. Circular Gravity Sewer Pipe Out @ 12 O'Clock

Pipe Material: **Clay** ☐ Pipe Lined

Invert Depth: **9.60** (ft.) Flow Characteristics: **Fast**

Deposits: ☒ None ☐ Mud ☐ Sludge ☐ Debris ☐ Grease

Infiltration: **None** Pipe Seal Cond: **Sound**

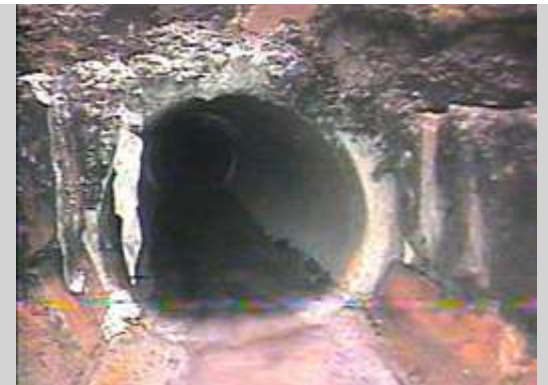
8 in. Circular Gravity Sewer Pipe In @ 7 O'Clock

Pipe Material: **Clay** ☐ Pipe Lined

Invert Depth: **9.53** (ft.) Flow Characteristics: **Fast**

Deposits: ☒ None ☐ Mud ☐ Sludge ☐ Debris ☐ Grease

Infiltration: **None** Pipe Seal Cond: **Sound**
